**BRIDGE CULVERT EVALUATION REPORT**  
**BOGGY CREEK WIDENING AND RECONSTRUCTION**  
**PROJECT**  
**Osceola County, Florida**

**PS-20-11479-DG**

**Prepared by:**  
**Dewberry Engineers Inc.**  
**800 N. Magnolia Avenue, Suite 1000**  
**Orlando, Florida 32803**

**March, 2021**

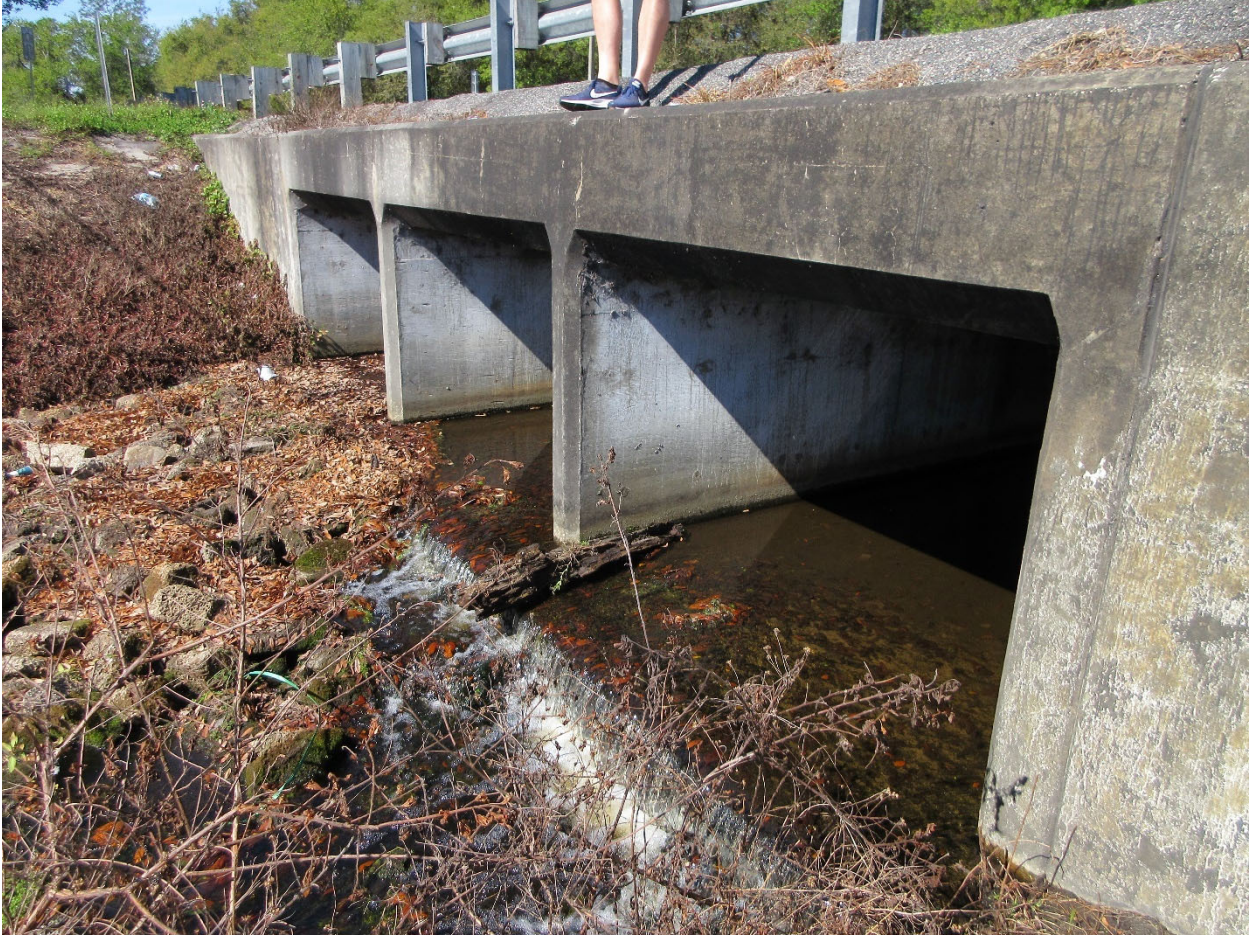
We noted in the field that the downstream cutoff wall is exposed. There is cracking and efflorescence as noted in the latest inspection report (see Appendix B). Comparing the existing conditions to the widening plans from 2009, we noted the top of asphalt elevation in the field does not match the plans. The plans show the height of asphalt even with the top of the headwalls, but in the field, we measured the top of asphalt to be 12" above the top of headwall.

Cutoff Wall Exposed

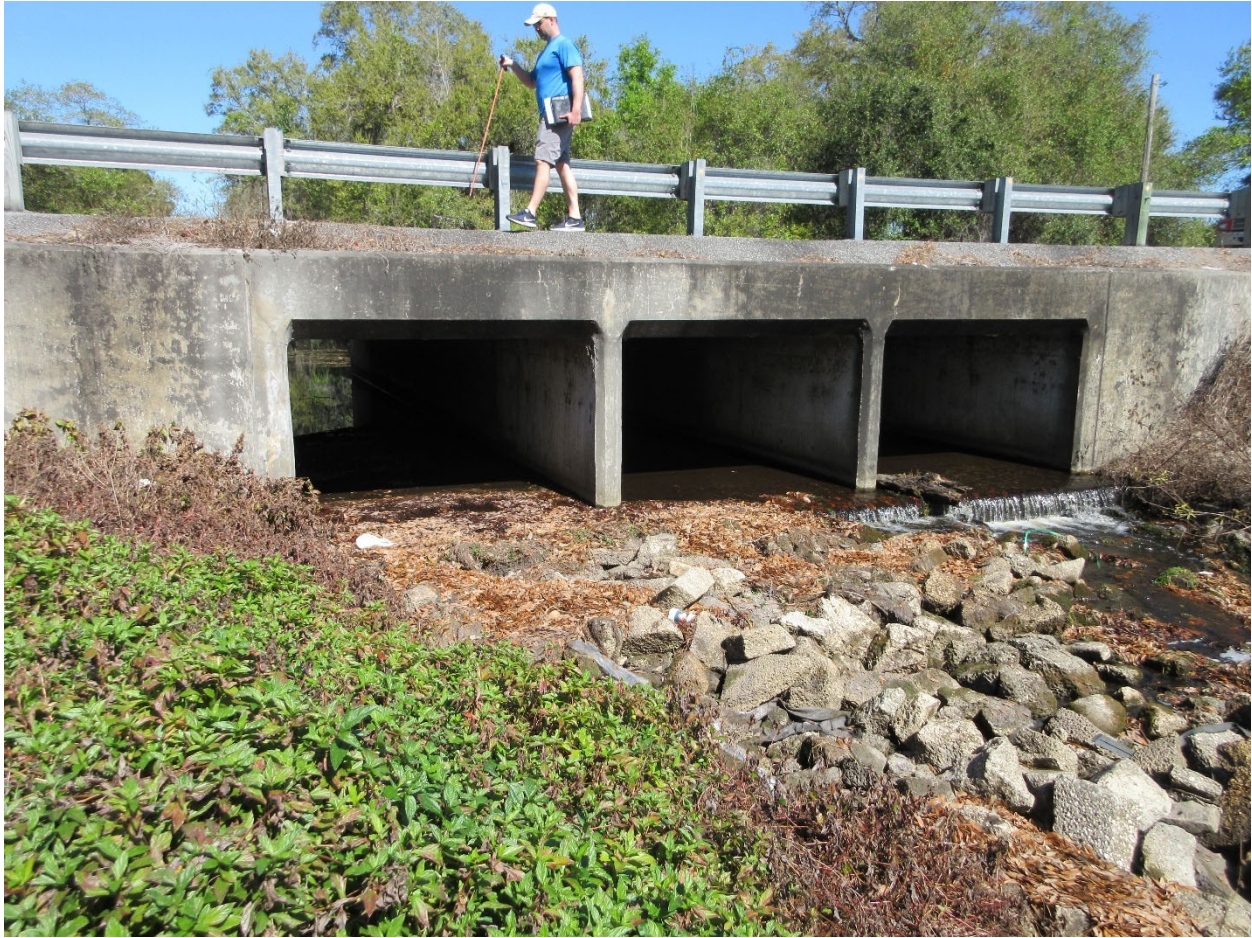
Bridge Culvert 924036 was originally built in 1950 and extended on both sides (10' left and 11' right) in 2011. It carries Jim Branch Creek under Boggy Creek Road approximately 1.15 miles west of Narcoossee Road (CR-15). The culvert is cast-in-place concrete and consists of three cells, 8 feet wide by 5 feet high and is 52' in length. At all four corners, the slope in front of the wingwalls is protected by 10-foot-wide concrete slope pavement. On the north side of the culvert (upstream side) at the time of our field review, the water was still and 6" deep. On the south side of the culvert (downstream side) the water is flowing much faster mainly out of the east barrel. The west barrel is full of debris and riprap is migrating downstream. (See Appendix A for pictures).

Culvert Downstream showing debris in Barrel

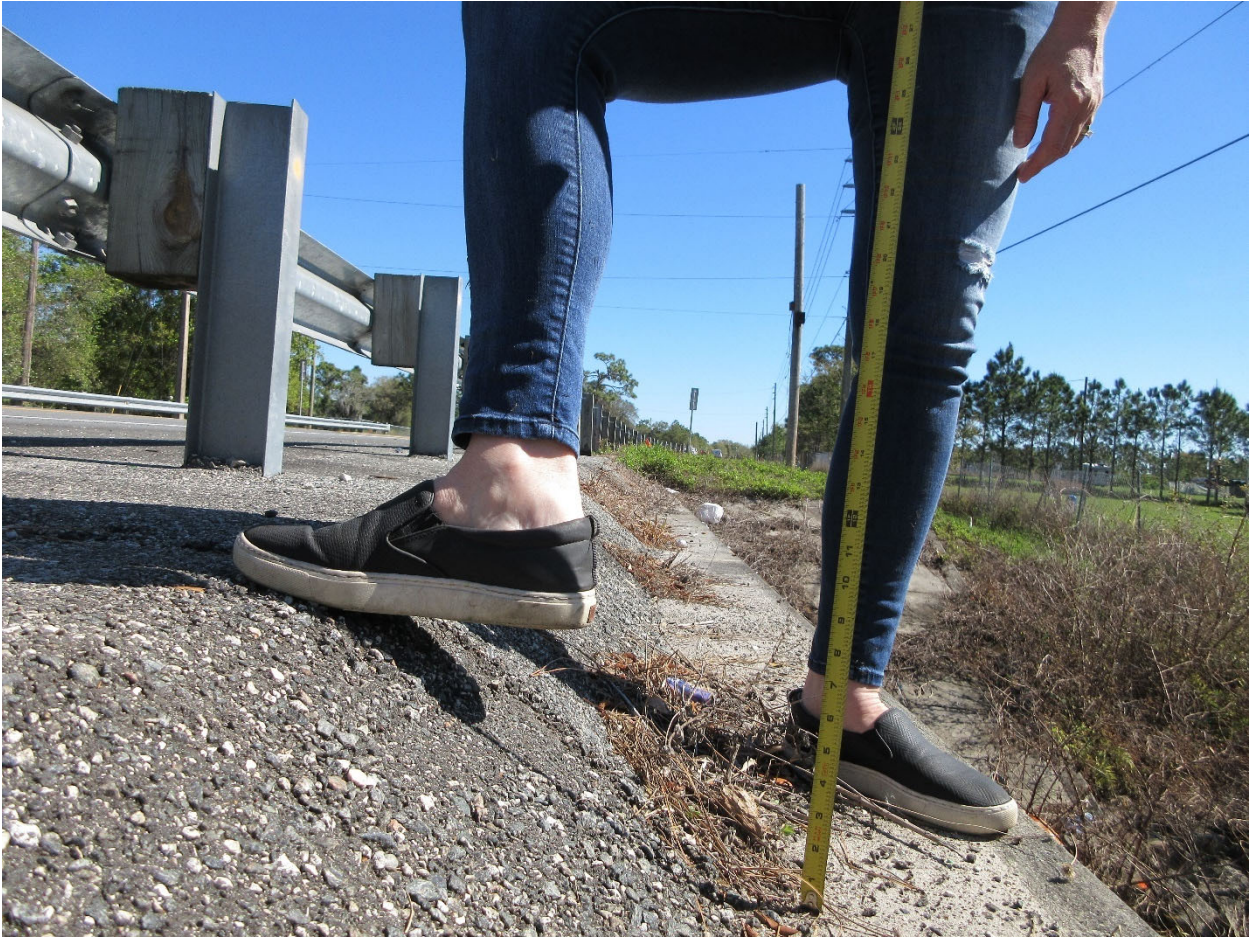
Asphalt at Headwalls

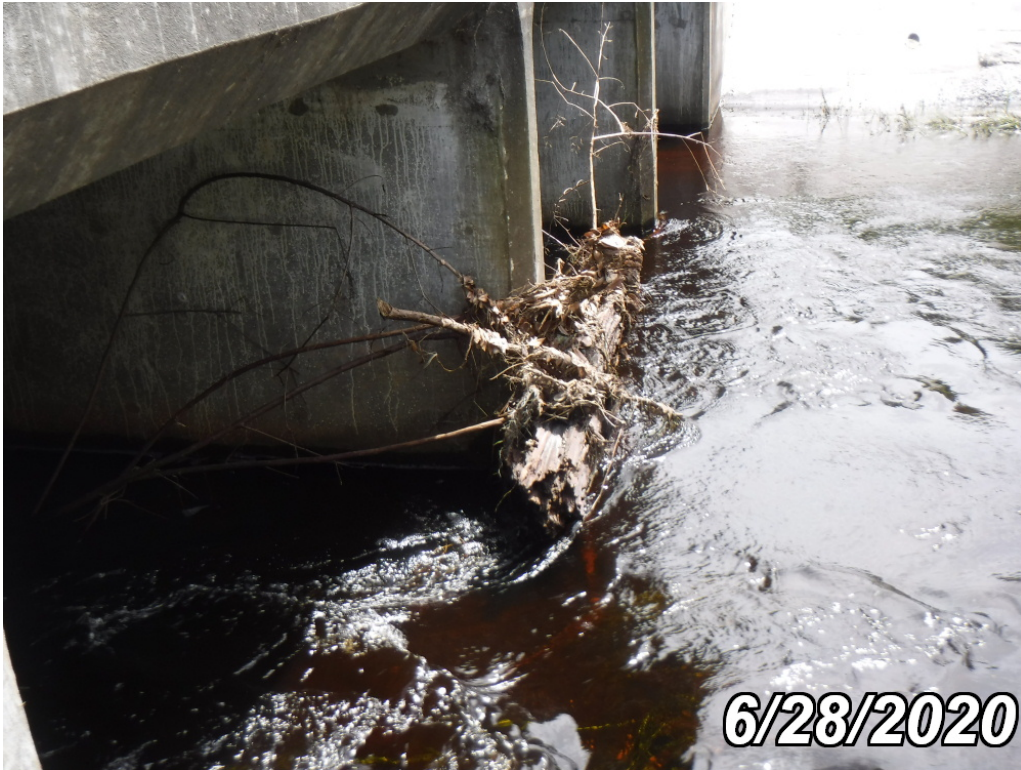
CS3 (9140) = There is debris buildup at the north end of Wall 3. Previously noted at both north ends of Walls 2 and 3. Refer to Photo 1. REPAIR (1EA)

Photo 1: Element 8290: Debris in channel at Wall 3.

Repair the exposure of the south toe wall at Cell 3.  
Remove the debris build up at the north end of Walls 2 and 3.

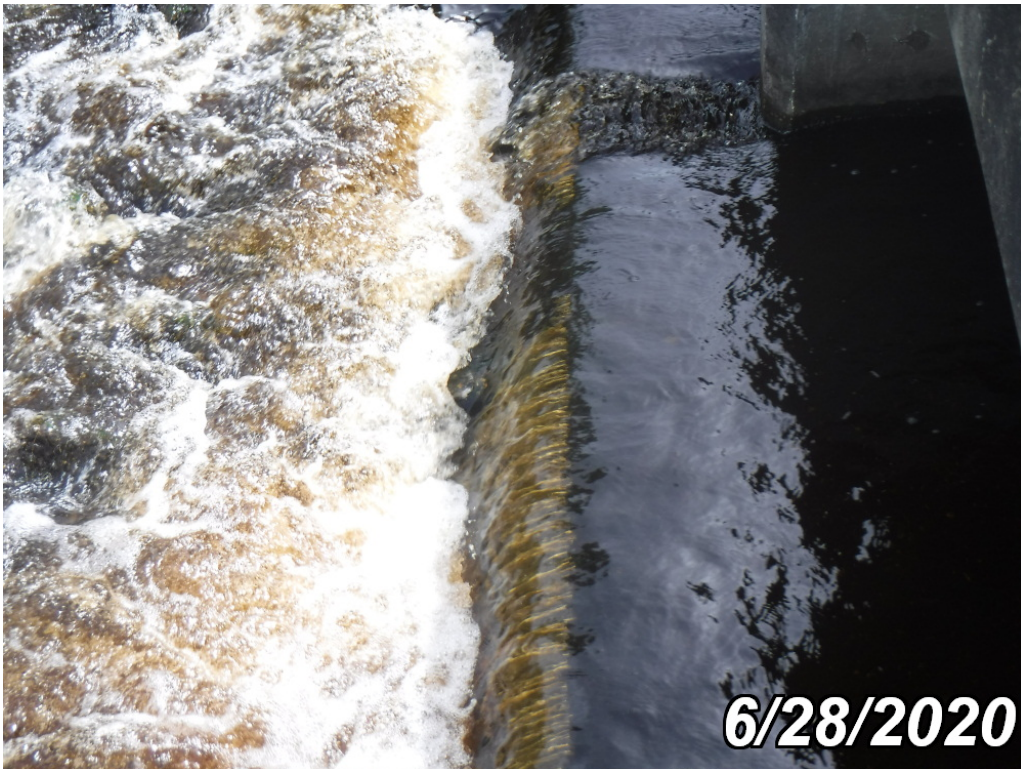
The south toe wall is exposed up to 14in. high at Cell 3 with no undermining noted (previously noted as minor exposure). Refer to Photo 2. REPAIR

Photo 2: Element 8290: South toe wall exposure at Cell 3.

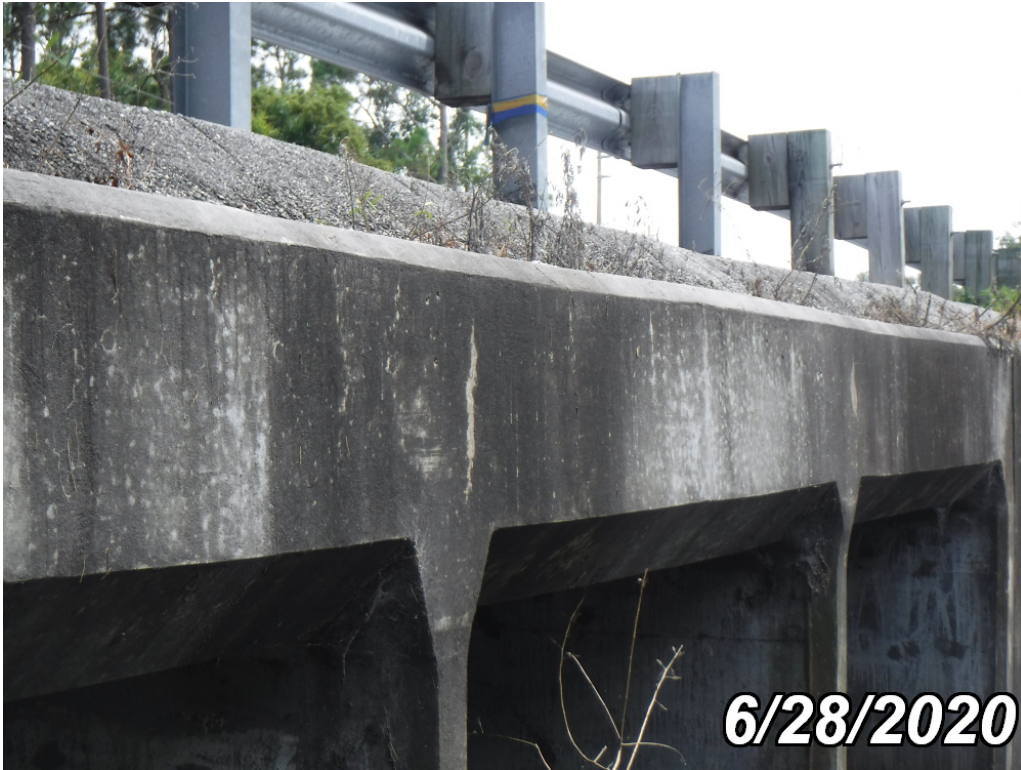
CS2 (1120) = There are 1/64in. W cracks with efflorescence in the north and south headwall over Walls 2 and 3. Refer to Photo 3. (2FT)

Photo 3: Element 8475: Vertical crack with efflorescence in north headwall.

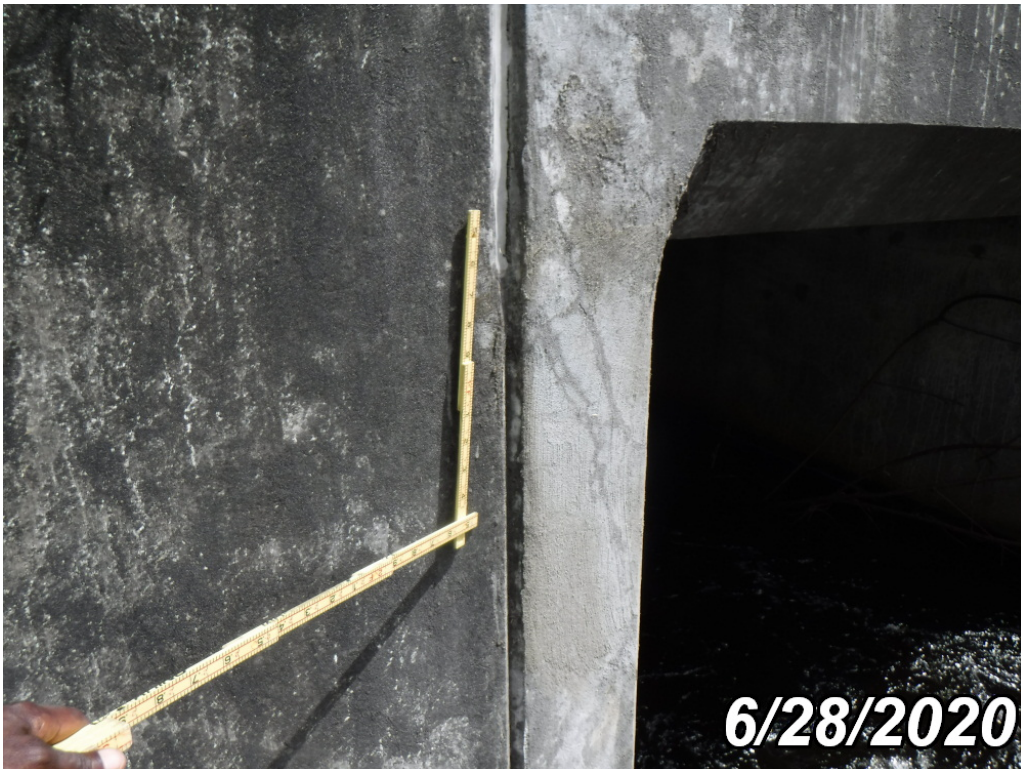
CS3 (1080) = There is a 2ft. H x 7in. W delaminated patch on the north end of Wall 4. Refer to Photo 4. REPAIR (2FT)

Photo 4: Element 241: Delaminated patch at the north end of Wall 4.

Repair the delaminated patch at the north end of Wall 4.  
Repair the patched crack with efflorescence and rust staining in the underside of Cell 2.

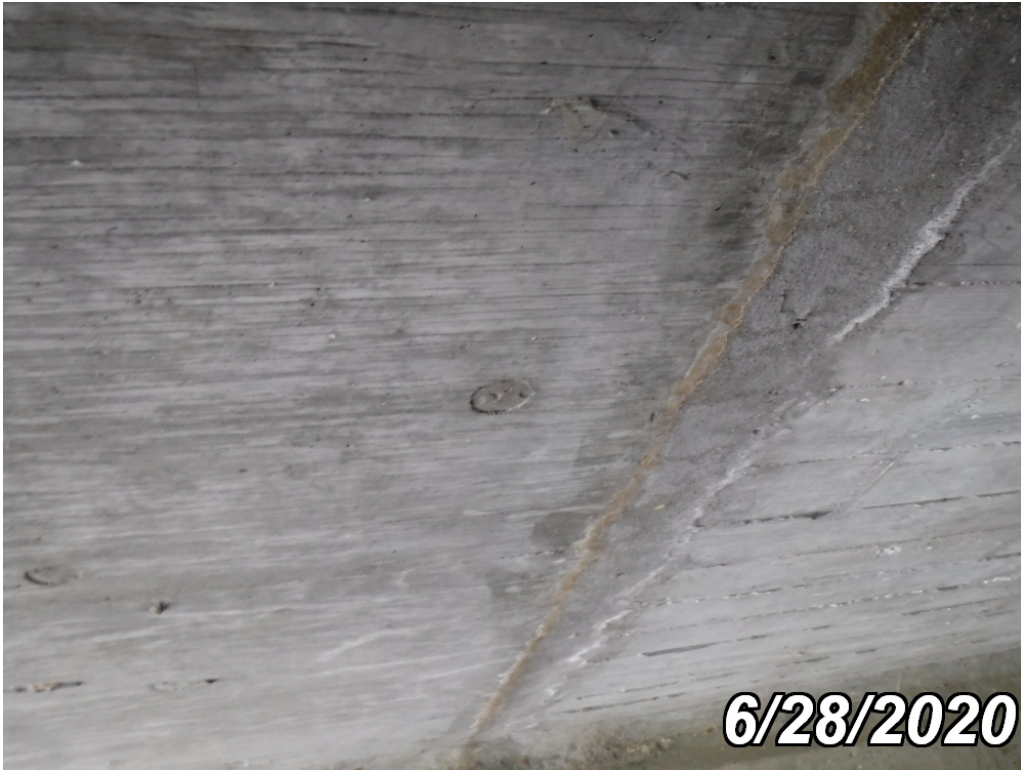
CS3 (1120) = The underside of Cells 1 and 2 has patched cracks with efflorescence and rust staining 10ft. from the north end at the cold joint. Refer to Photo 5. REPAIR (8FT)

Photo 5: Element 241: Patched crack with efflorescence and rust staining in the underside of Cell 2 at the cold joint.

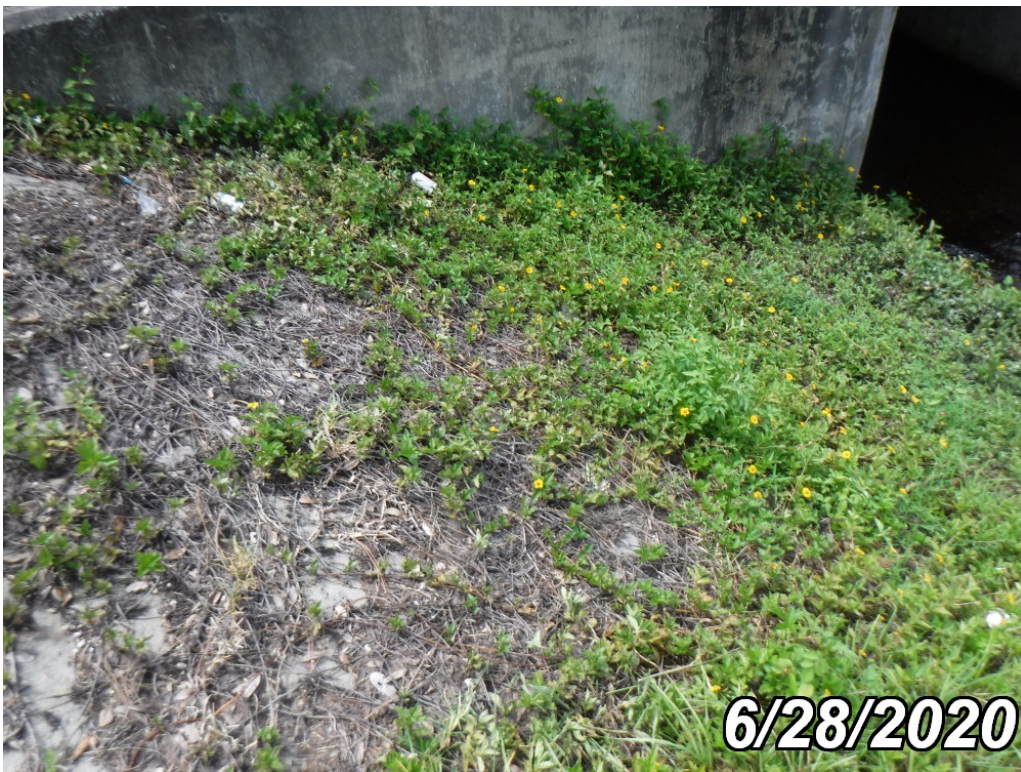
There is vegetation on all slope protections. Refer to Photo 6. REPAIR

Photo 6: Element 8394: Heavy vegetation growth on the southwest slope protection.

Clean and clear out clogged weep holes at the slope protection.  
Herbicide vegetation growth on the slope protection.

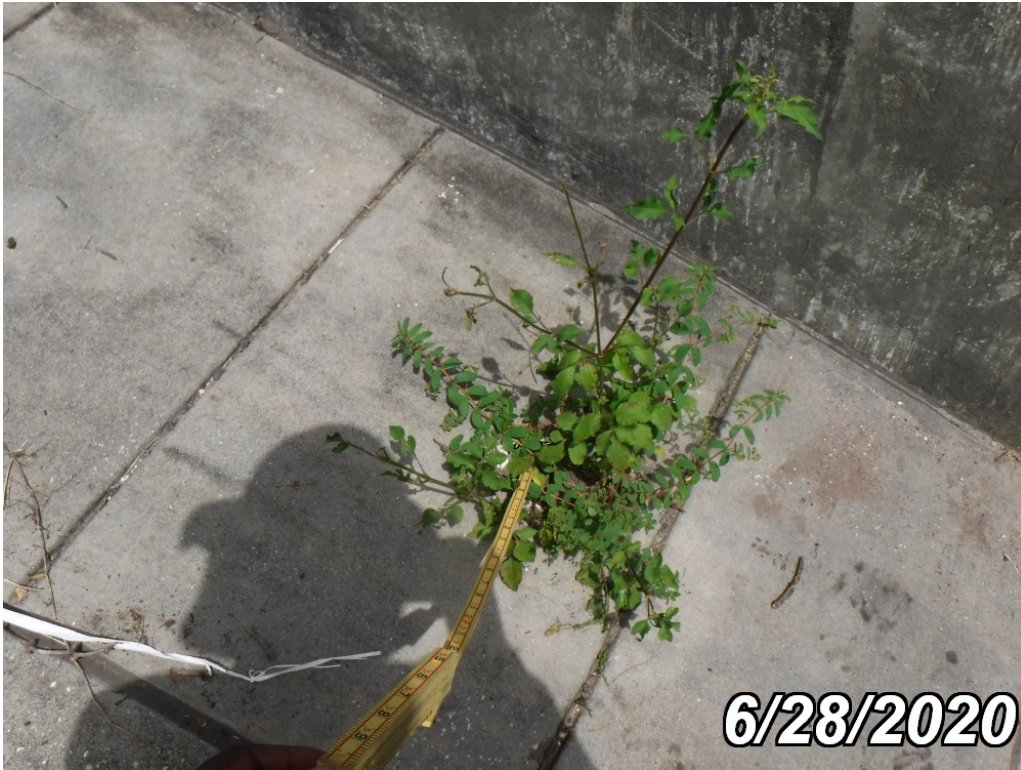
The slope protection weep holes are clogged with dirt and vegetation. Refer to Photo 7. REPAIR.

Photo 7: Element 8394: Clogged weep hole at the northwest slope protection.
