CONTAMINATION SCREENING EVALUATION REPORT

BOGGY CREEK ROAD WIDENING From Simpson Road to Narcoossee Road

Osceola County, Florida
PS-20-11479-DG
GEC Project No. 4636E

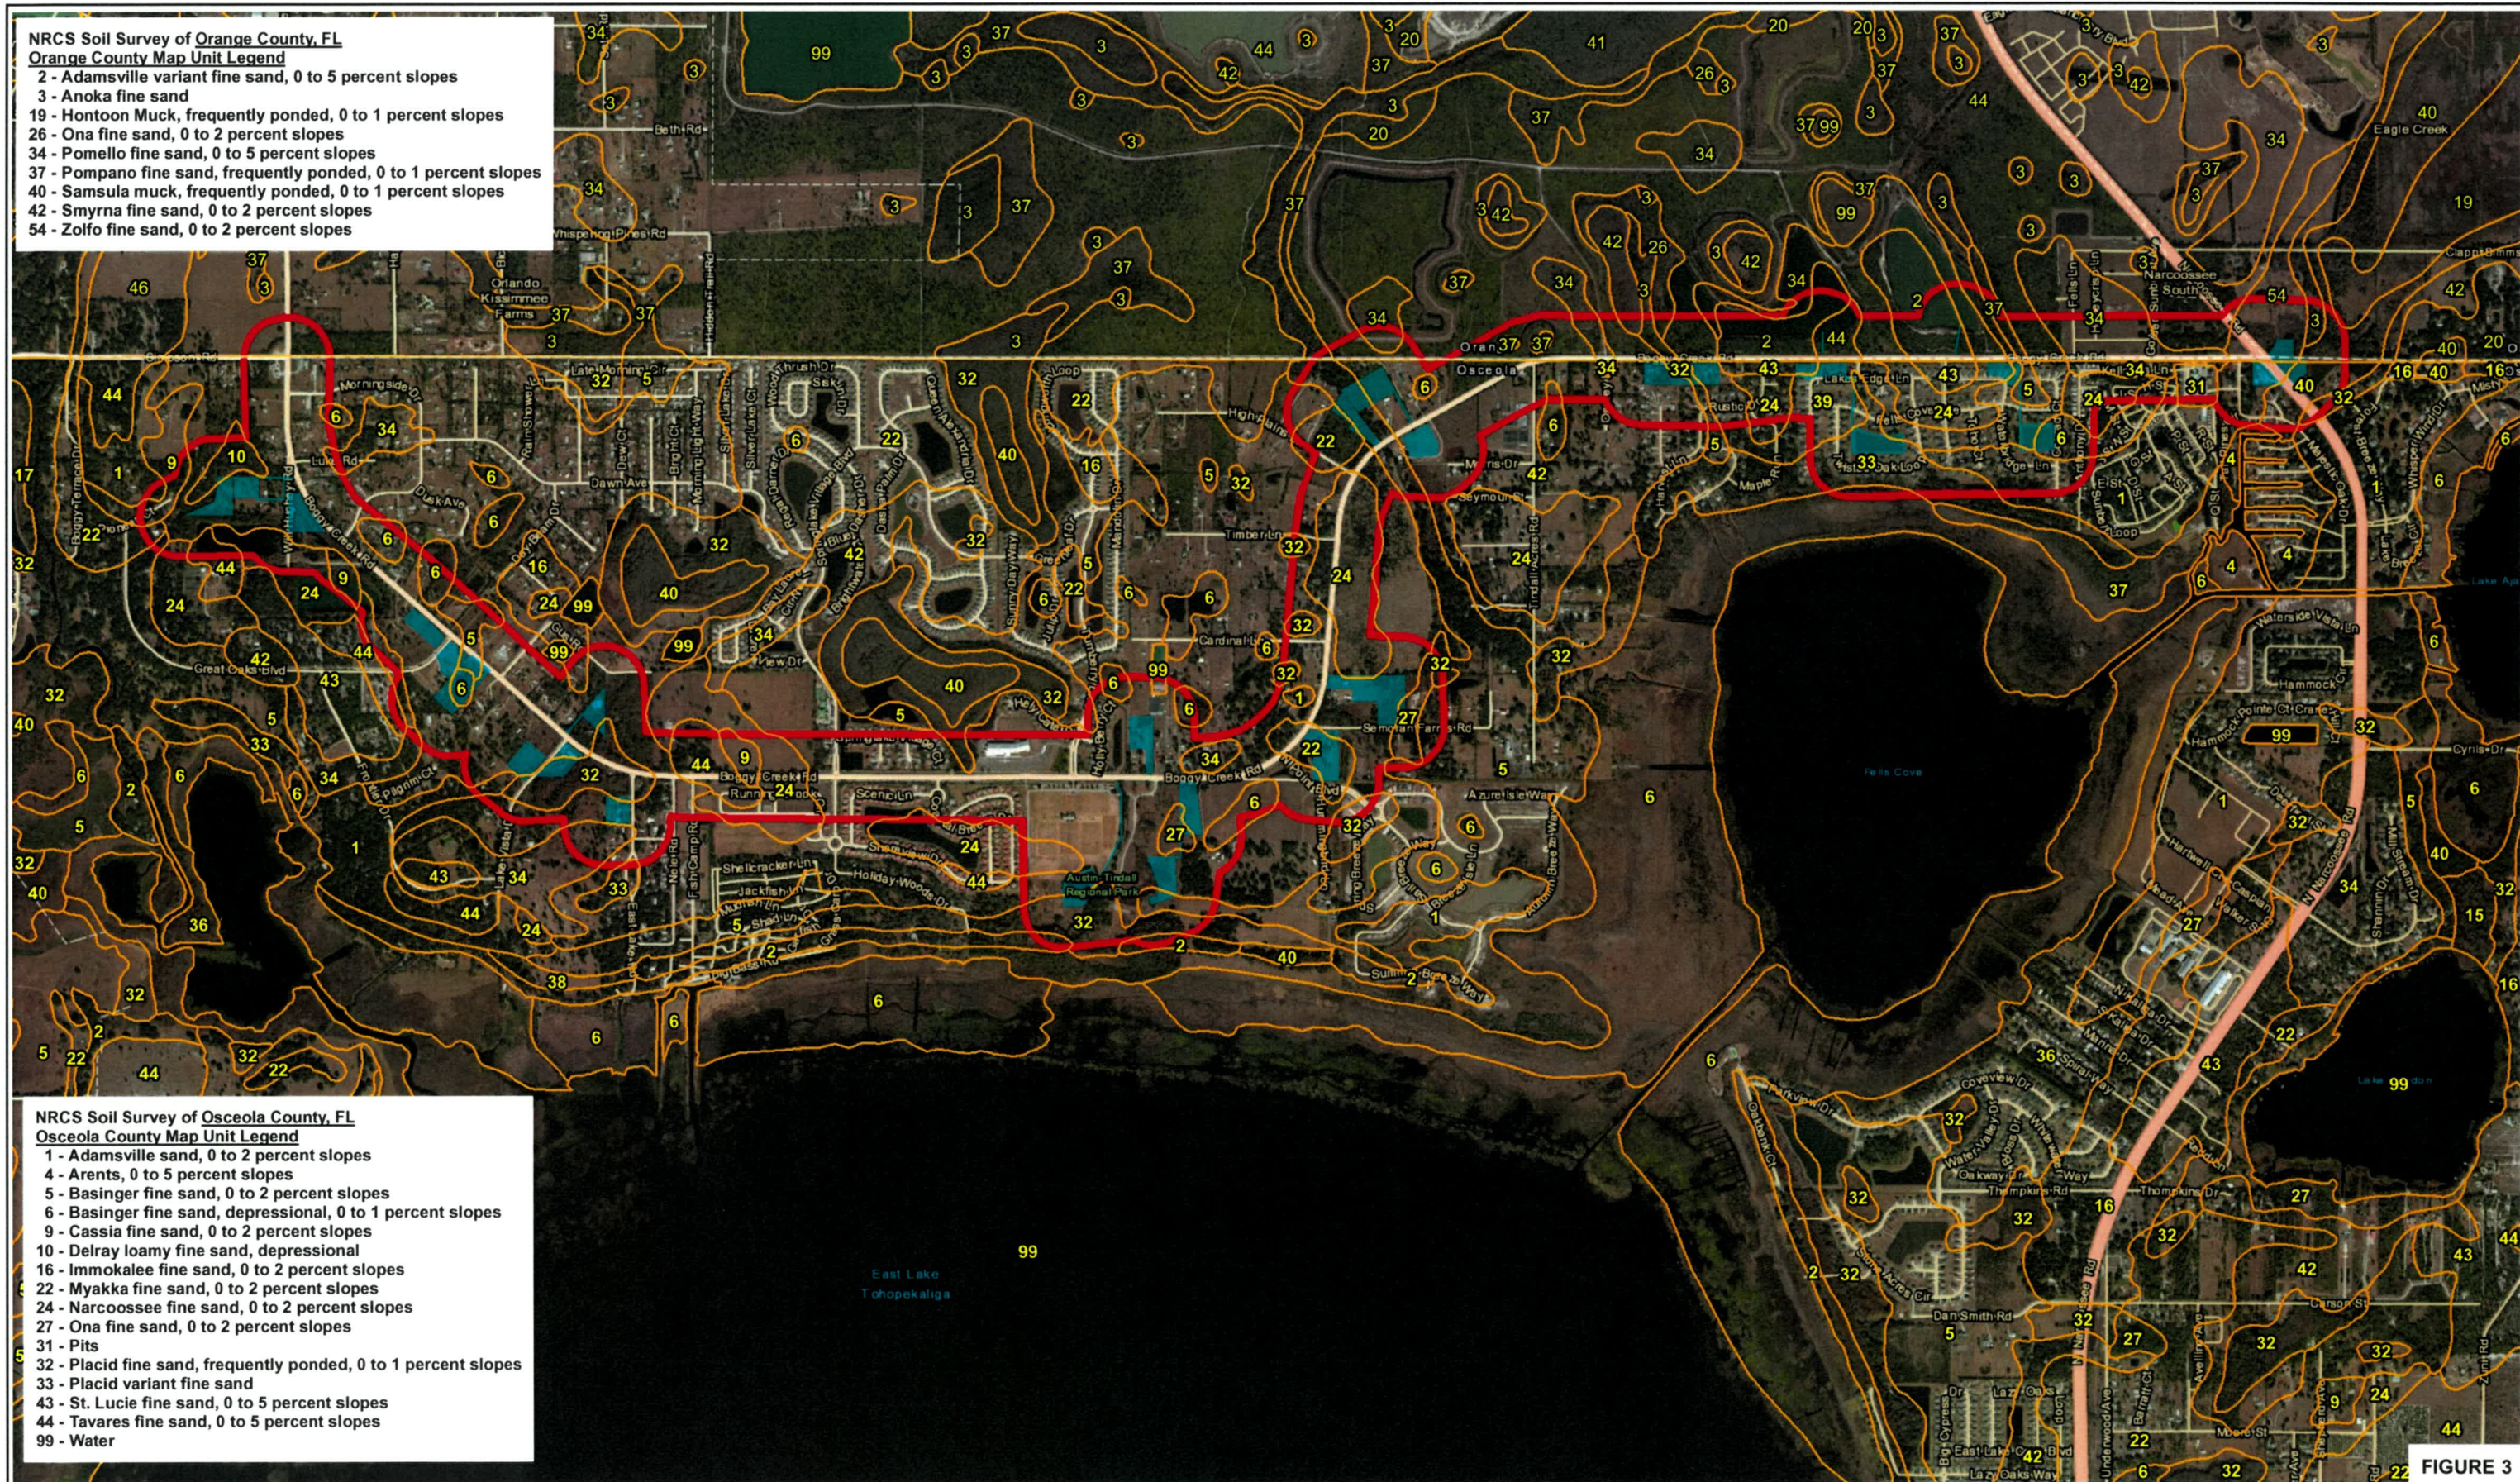
FIGURE 3

The NRCS Soil Surveys of Orange and Osceola Counties, Florida were reviewed for information regarding near-surface soil conditions within the project limits, as shown on **Figure 3**. The following soil types were identified within the study area:

- 1 - Adamsville sand, 0 to 2 percent slopes
- 4 - Arents, 0 to 5 percent slopes
- 5 - Basinger fine sand, 0 to 2 percent slopes
- 6 - Basinger fine sand, depressional, 0 to 1 percent slopes
- 9 - Cassia fine sand, 0 to 2 percent slopes
- 10 - Delray loamy fine sand, depressional
- 16 - Immokalee fine sand, 0 to 2 percent slopes
- 22 - Myakka fine sand, 0 to 2 percent slopes
- 24 - Narcoossee fine sand, 0 to 2 percent slopes
- 27 - Ona fine sand, 0 to 2 percent slopes
- 31 - Pits
- 32 - Placid fine sand, frequently ponded, 0 to 1 percent slopes
- 33 - Placid variant fine sand
- 43 - St. Lucie fine sand, 0 to 5 percent slopes
- 44 - Tavares fine sand, 0 to 5 percent slopes
- 99 - Water

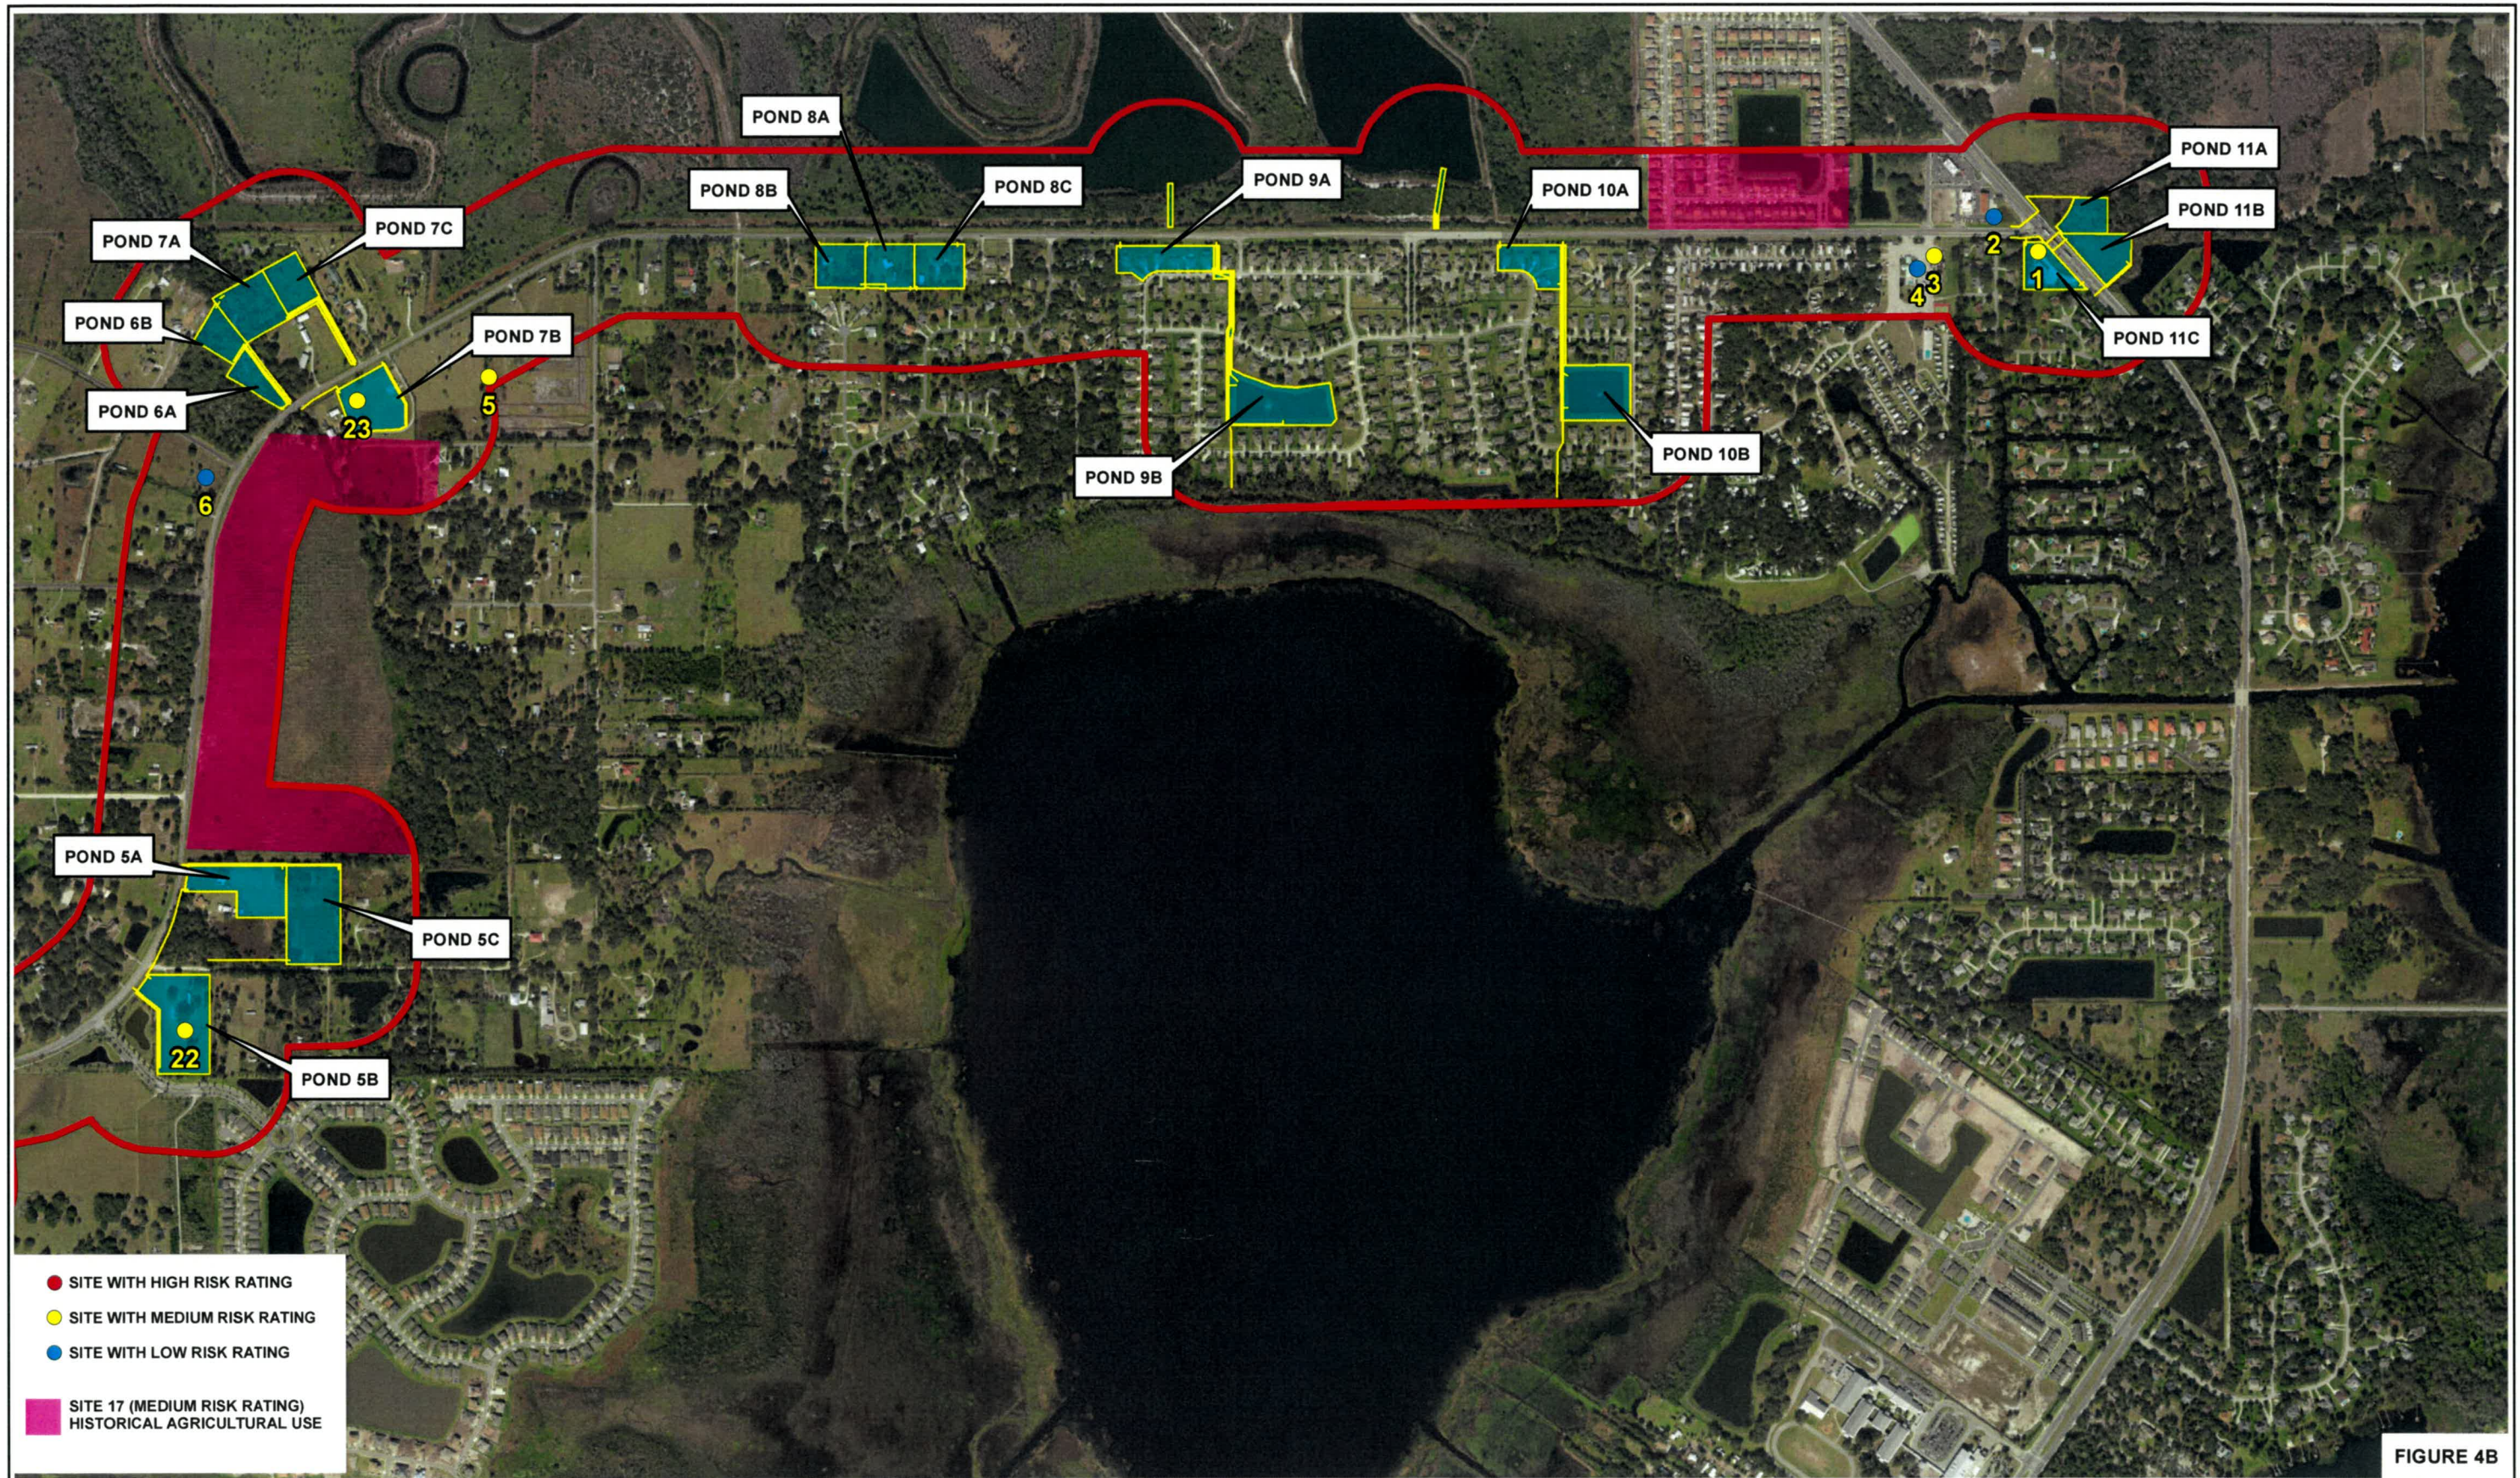
FIGURE 4B

- SITE WITH HIGH RISK RATING
- SITE WITH MEDIUM RISK RATING
- SITE WITH LOW RISK RATING
- SITE 17 (MEDIUM RISK RATING)
HISTORICAL AGRICULTURAL USE

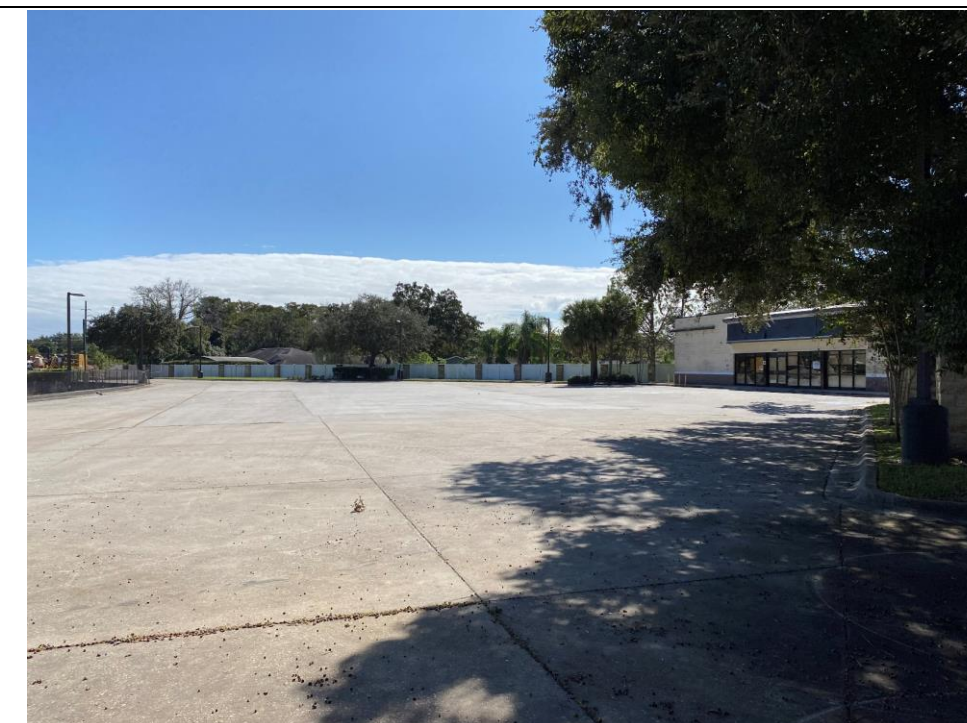
CONCLUSIONS: Based on the historical gas station use of this location and this location being proposed for use as a stormwater pond, this site has been assigned a Contamination Risk Rating (CRR) of **MEDIUM**.

View of the facility from the northwest corner facing southeast toward the vacant convenience store and former dispenser islands and USTs.

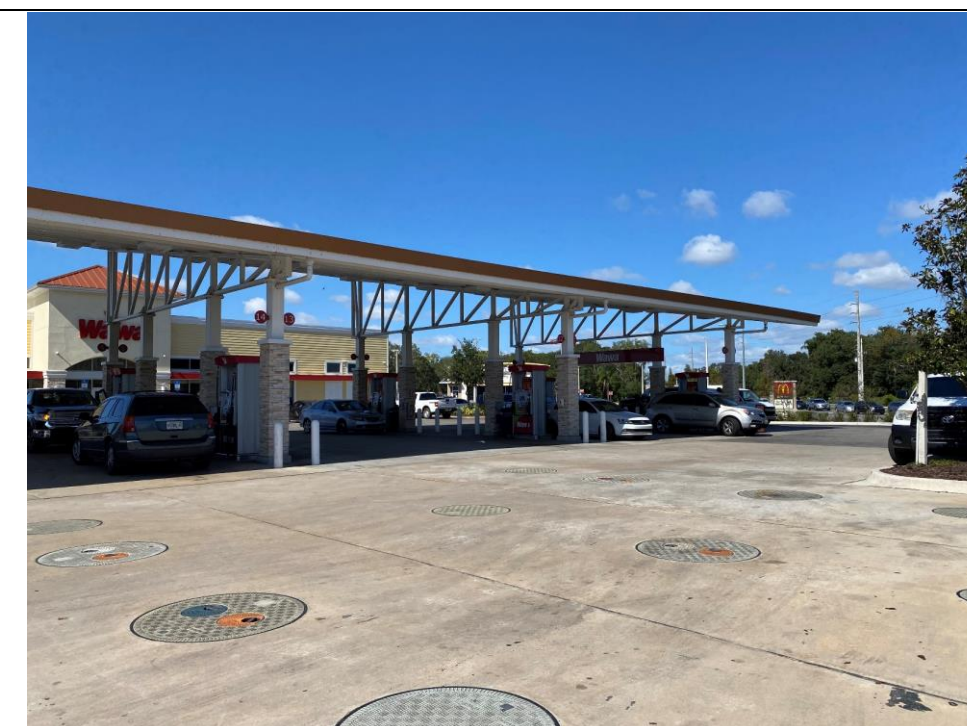
CONCLUSIONS: Based on the lack of reported contamination at the facility, the Wawa Food Mart facility has been assigned a CRR of **LOW**.

View across the facility from the southeast corner facing northwest, towards the dispensers and convenience store.

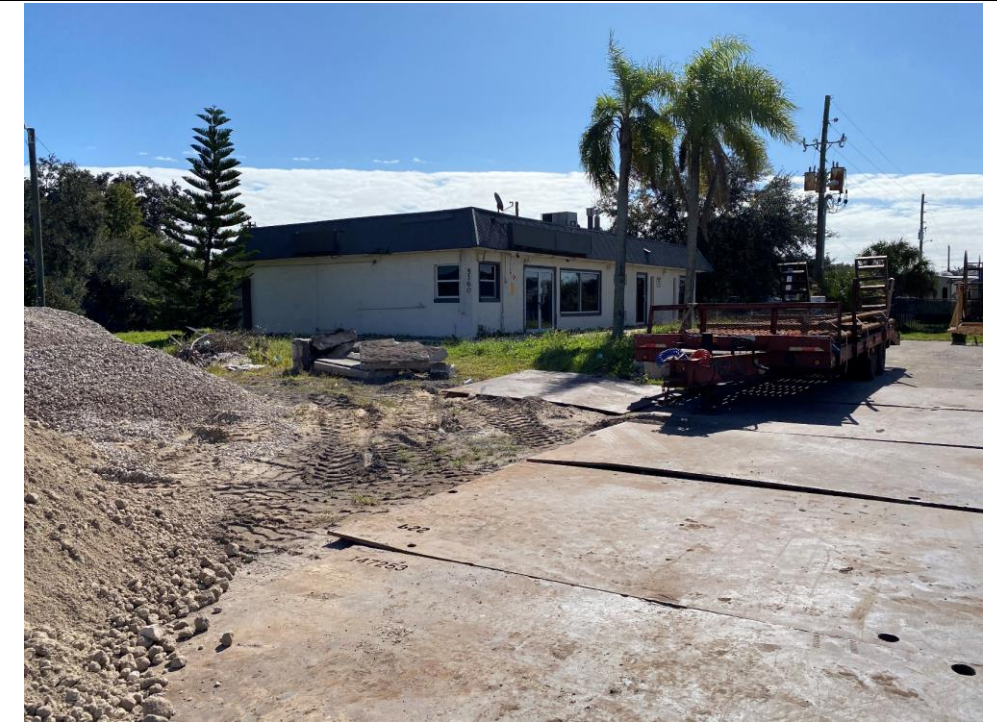
CONCLUSIONS: Although the soil and groundwater contamination has been delineated and is approximately 150 feet or more from the roadway and extending away from Boggy Creek Road, remediation has not yet begun at the facility. Therefore, the former Boggy Creek Food & Gas facility has been assigned a CRR of **MEDIUM**.

View of the former commercial building and stockpiled soils, facing southeast from the northern portion of the site. Piles of soil and gravel were observed on the north end of the site.

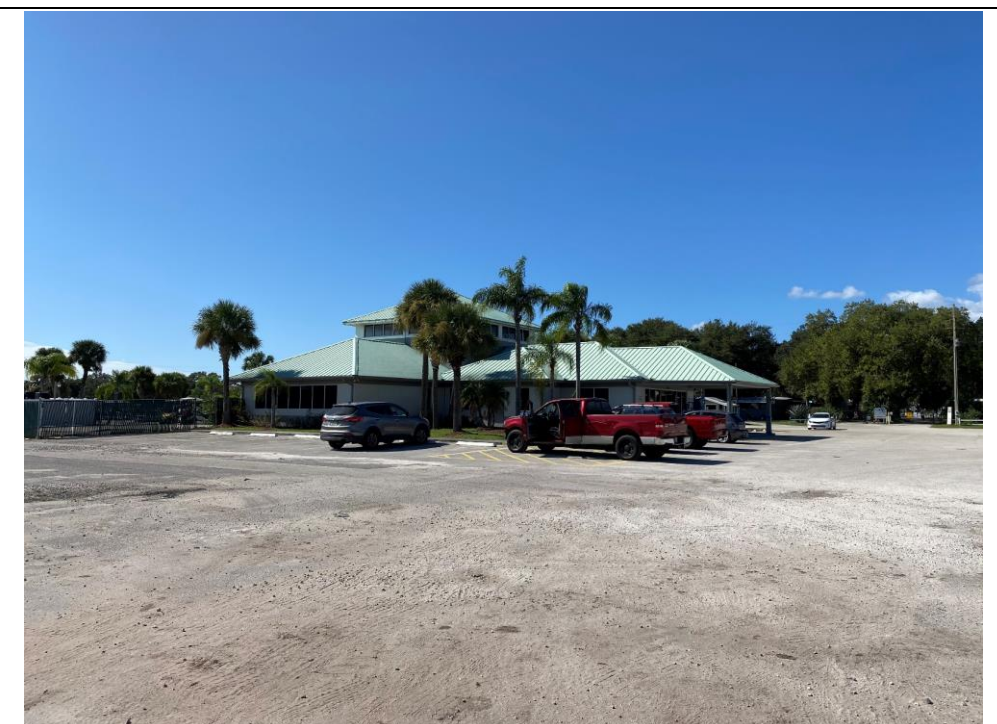
CONCLUSIONS: Based on the lack of reported contamination at the facility within the study area boundaries, the Floridian RV Resort facility has been assigned a CRR of **LOW**.

View of the office building at the north end of the property, facing southwest.

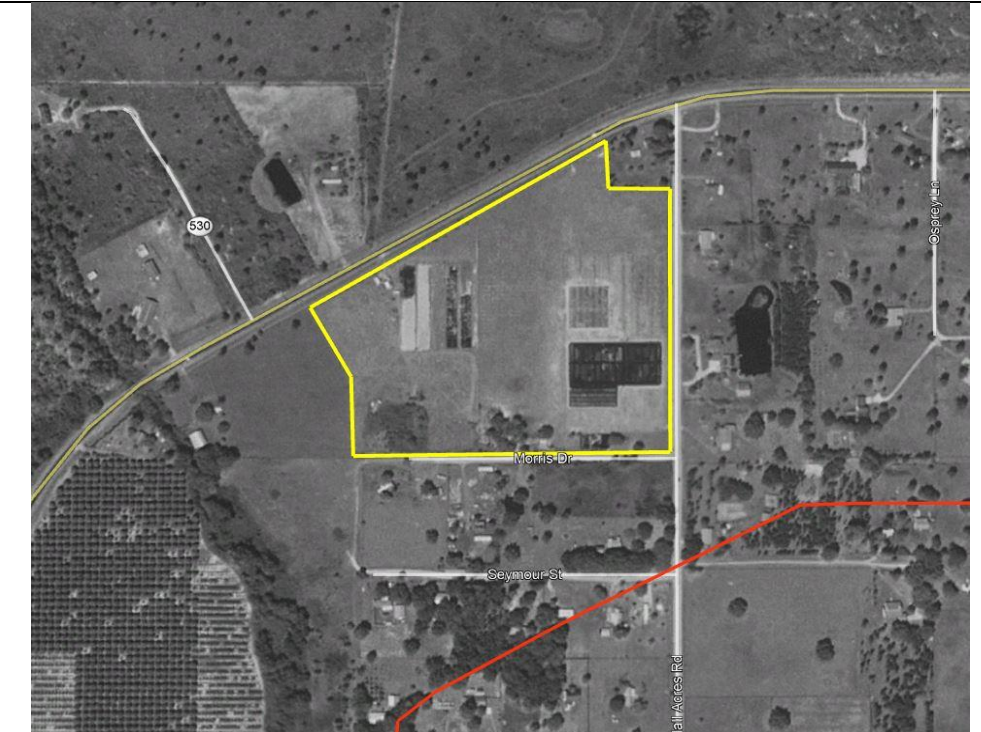
CONCLUSIONS: Based on the redevelopment of the former facility into a "sensitive receptor" type facility (a school campus) with no reported contamination and no ponds being proposed at this location, this facility has been assigned a CRR of **LOW**.

1994 aerial photograph from Google Earth depicting the nursery areas, south of Boggy Creek Road, within the Study Area.

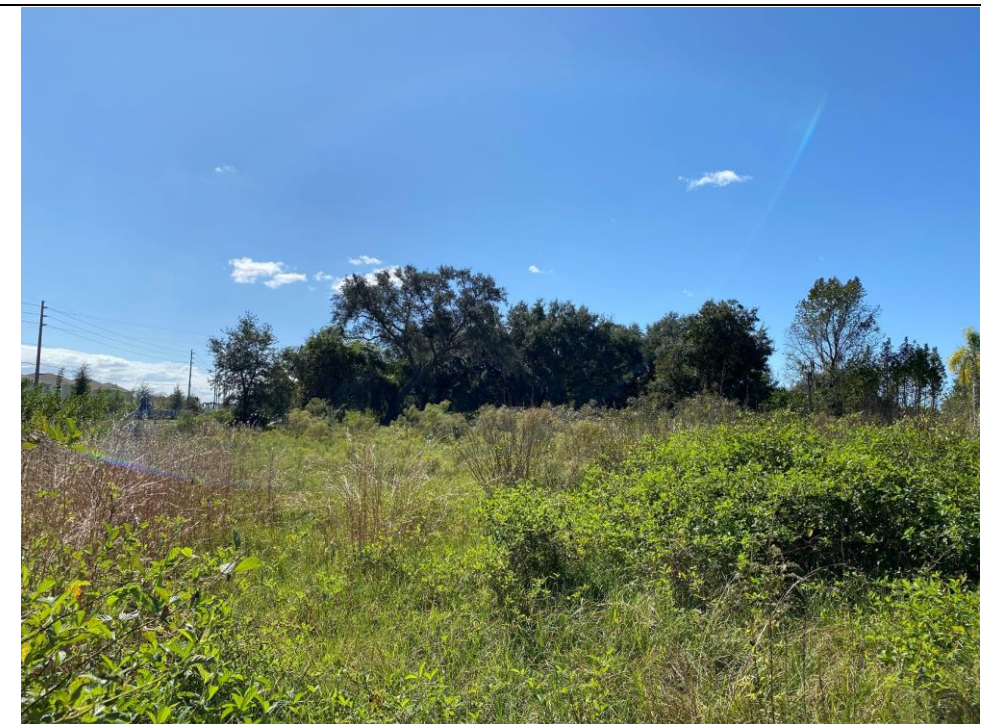
CONCLUSIONS: Based on the temporary, as-needed basis of this facility and no reported contamination, this facility has been assigned a CRR of **LOW**.

View across the former facility from High Plains Lane, facing south.

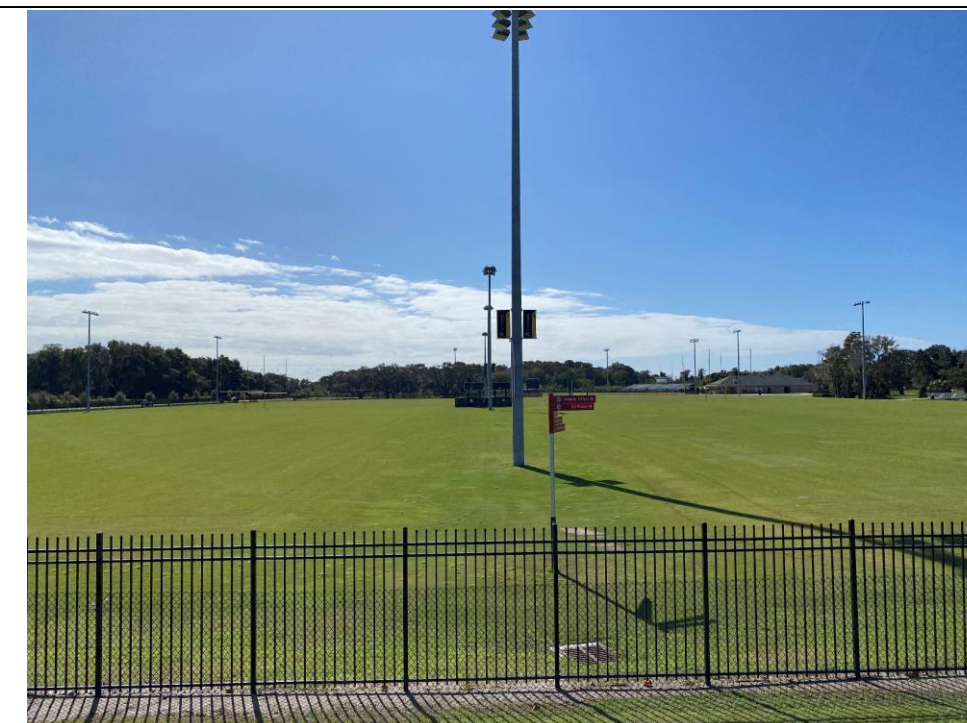
CONCLUSIONS: Based on the temporary, as-needed basis of this facility and no reported contamination, this facility has been assigned a CRR of **LOW**.

View facing south across one of the facility's numerous soccer/recreational fields.

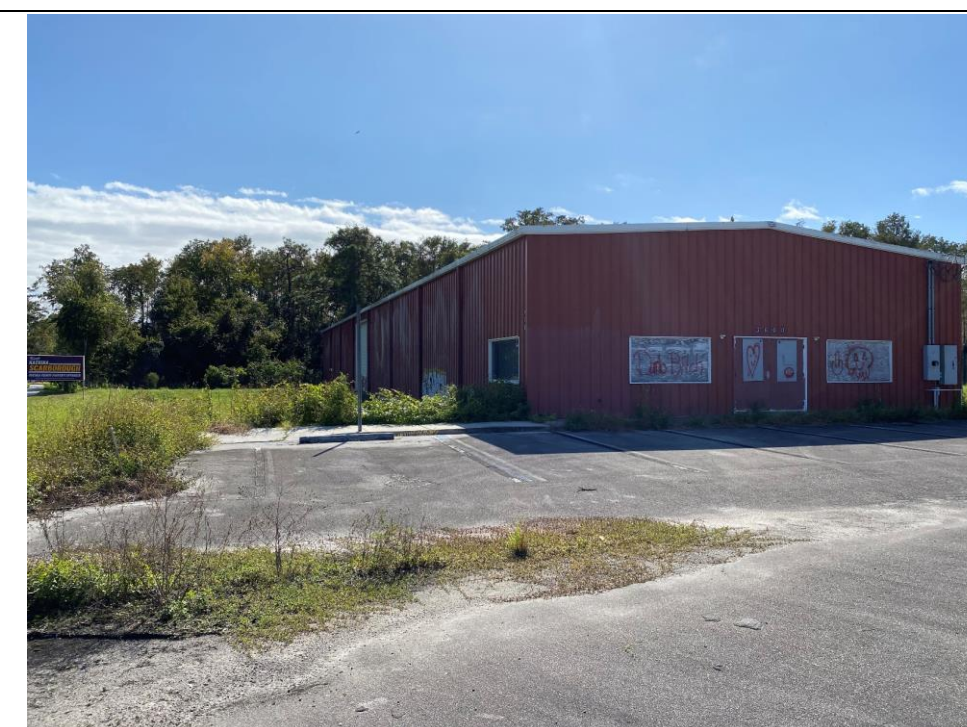
CONCLUSIONS: Based on the former auto salvage yard and the proposed pond site at this facility, the Florida Sterling Investments facility has been assigned a CRR of **HIGH**.

View of the vacant warehouse and paved parking area on the northern side of the property.

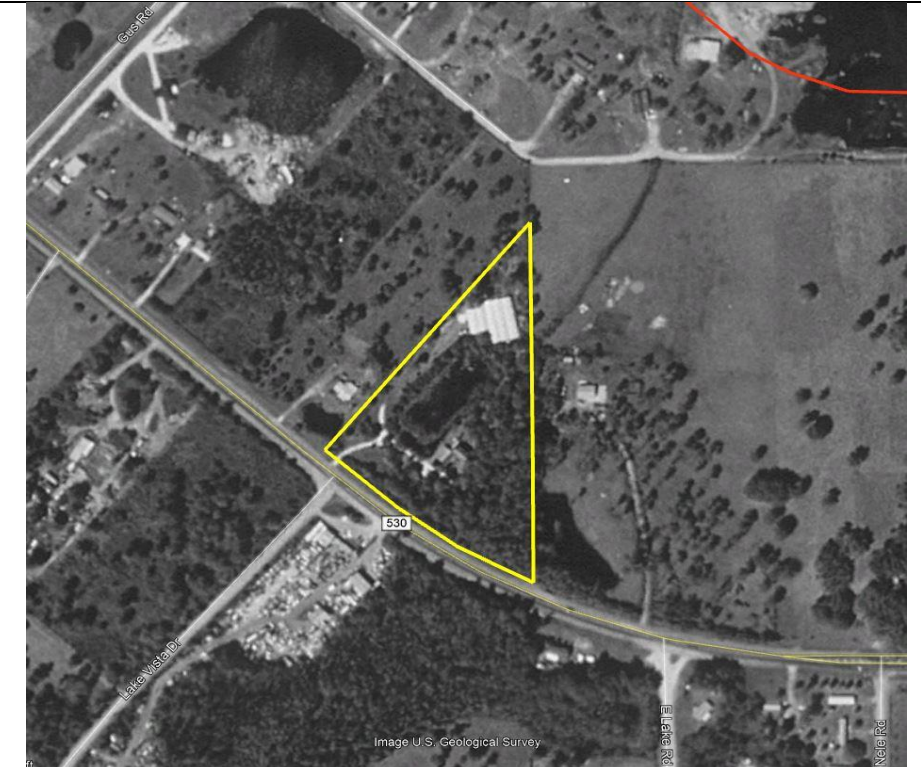
CONCLUSIONS: Based on the former plant nursery site usage and the proposed pond site use of this location, the former nursery facility has been assigned a CRR of **MEDIUM**.

1994 aerial photograph from Google Earth depicting the former greenhouses, residence, and excavation pit.

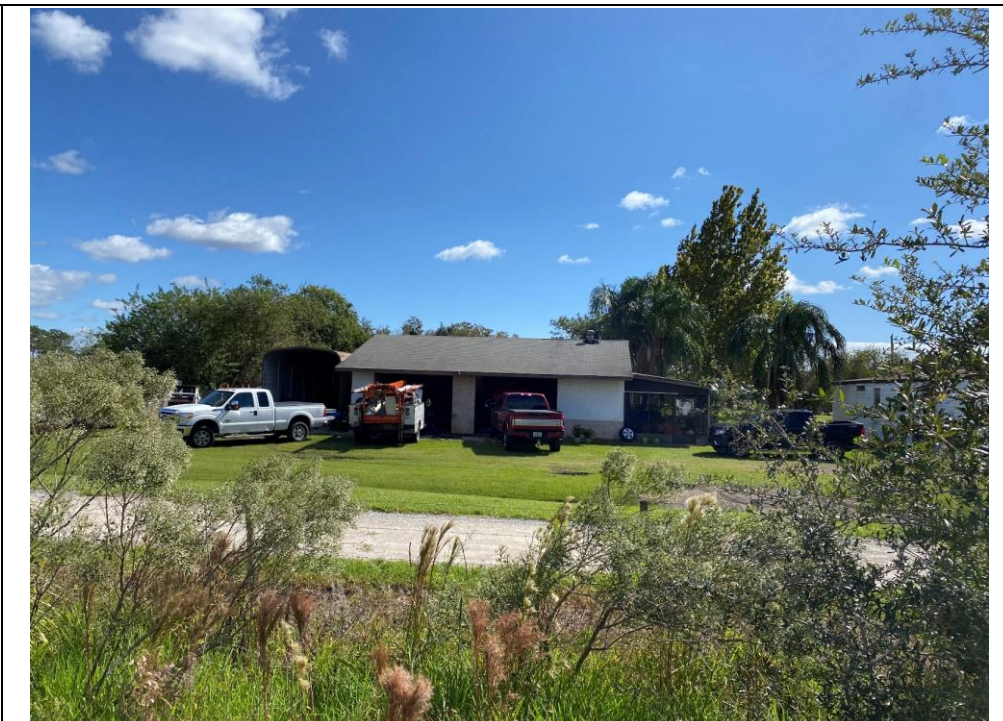
CONCLUSIONS: Based on the lack of reported contamination at the facility, the unnamed auto repair facility has been assigned a CRR of **LOW**.

View of the garage/shop located behind the residence, facing southeast from Gus Road.

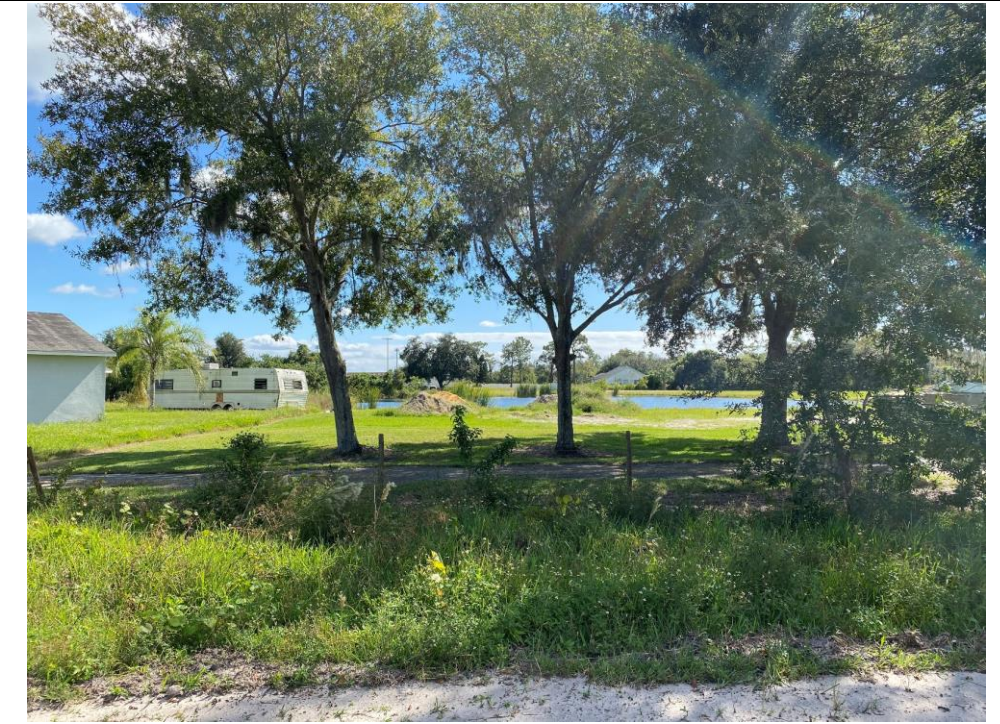
CONCLUSIONS: The areas of stained soil and apparent contamination is located approximately 400 feet from Boggy Creek Road, on the south-southwest side of the garage. The excavated area is/was approximately 550 feet from the alignment. Based on the distance of the contamination from the alignment and the amount of time since contamination was reported, the former Williams Pit facility has been assigned a CRR of **LOW**. If the property is ever considered for a pond site or other land use, the CRR would increase to **HIGH**.

View of the residence and the southern portion of the excavated pond from Gus Road, facing southeast.

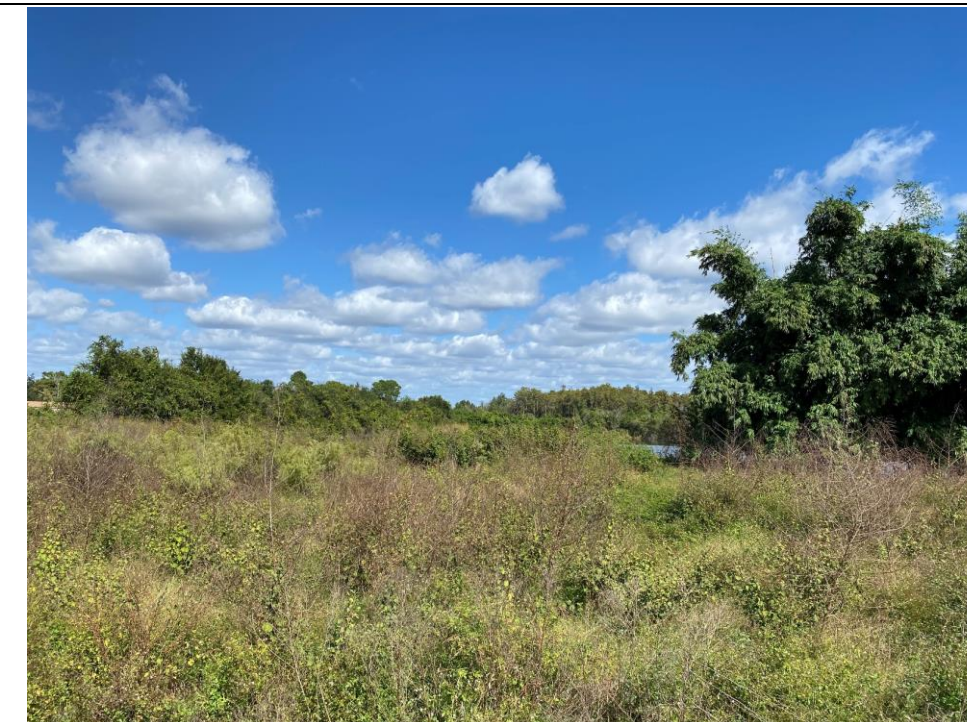
CONCLUSIONS: Based on the distance from Boggy Creek Road and the lack of reported contamination at the facility, the former Jackson Landfill facility has been assigned a CRR of **LOW**. If the property is ever considered for a pond site or other land use, the CRR would increase to **HIGH**.

View across the former Jackson Landfill facing northeast from Gus Road.

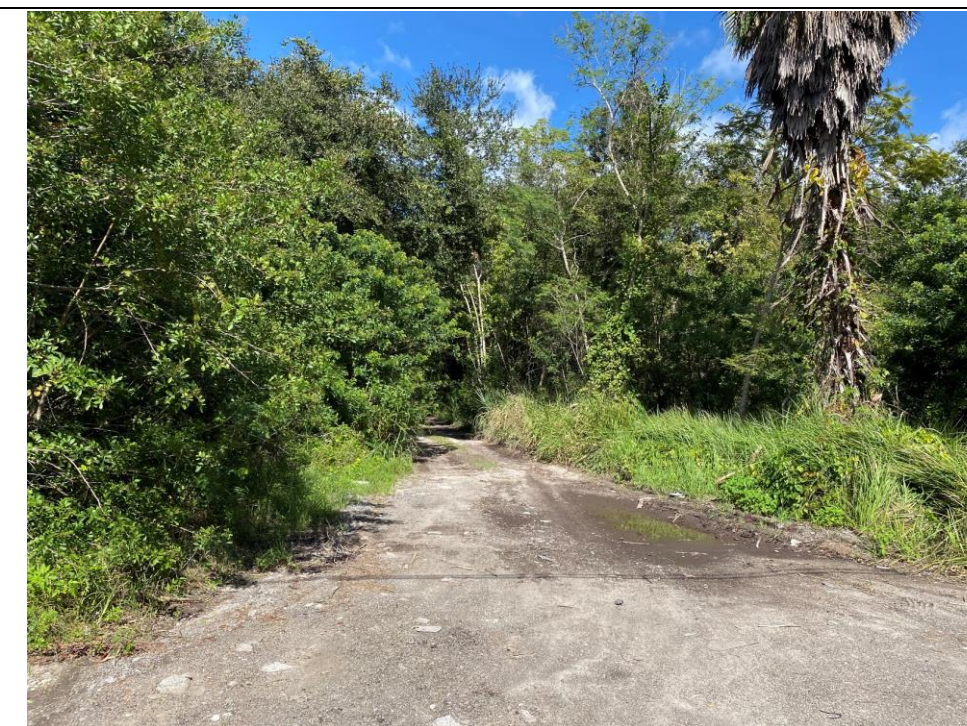
CONCLUSIONS: Based on the lack of reported contamination at the facility and its location outside of the Study Area boundaries, the unnamed former landfill facility has been assigned a CRR of **LOW**.

View of a driveway going into the center of the former unnamed landfill facility, facing north from Luke Road.

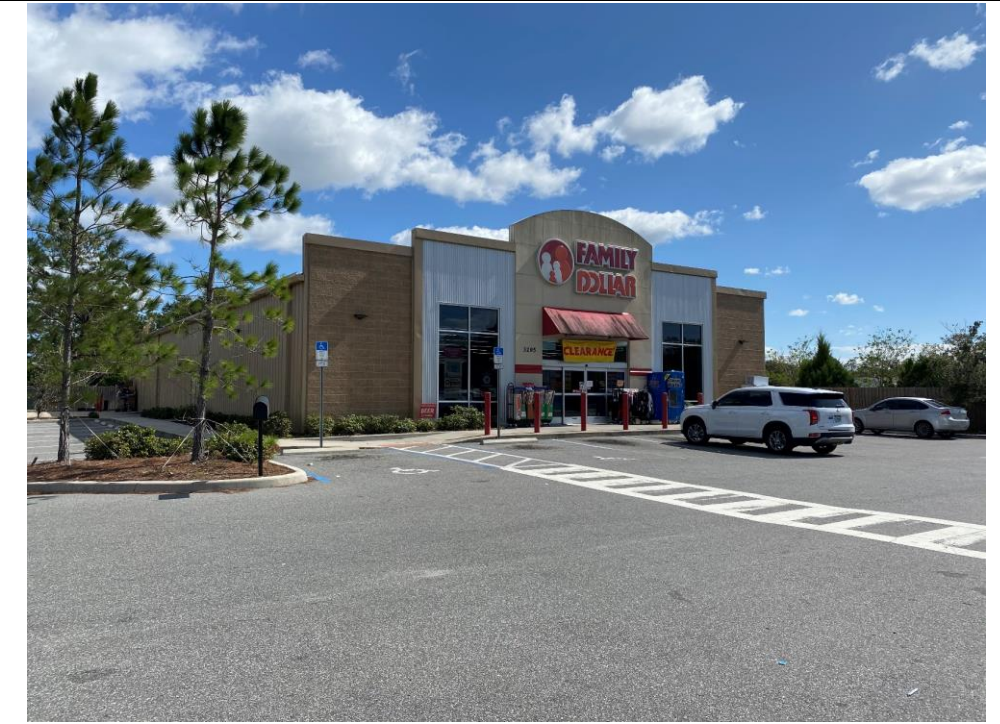
CONCLUSIONS: Based on the lack of reported contamination at the facility, the former facility has been assigned a CRR of **LOW**.

View of the Family Dollar retail store from the northwest corner of the property, facing southeast.

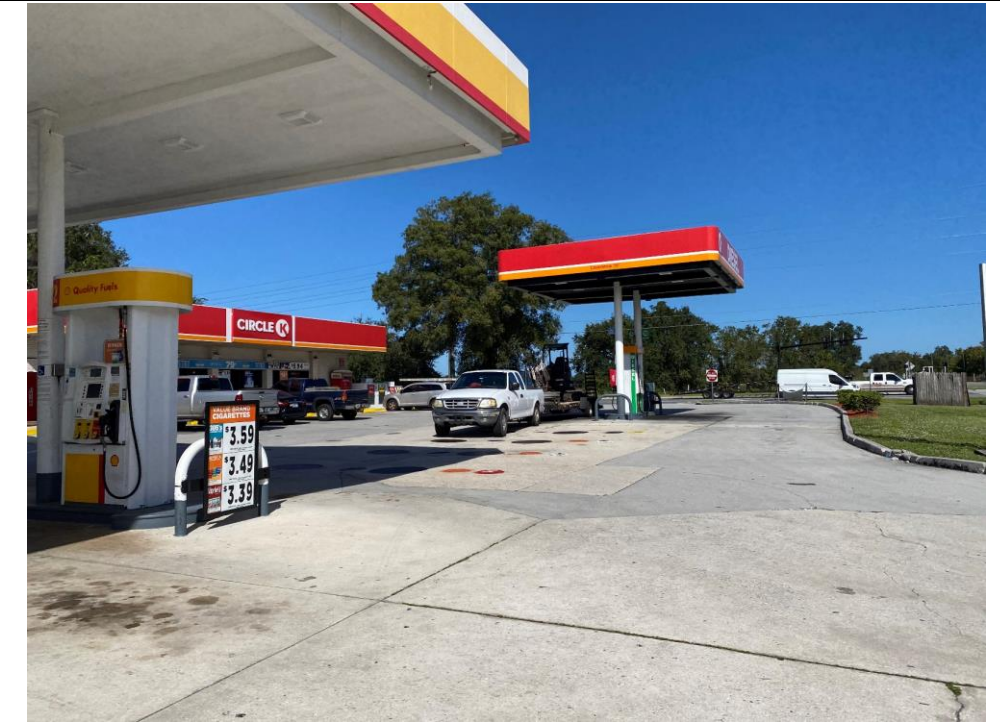
CONCLUSIONS: While the groundwater plume at the facility has been delineated to the north, east, and south, contamination remains at the facility above target levels, and has migrated off-site to the west, towards a drainage ditch. Based on the proximity to the Study Area, the Circle K facility has been assigned a CRR of **MEDIUM**.

View of the gasoline dispenser island (yellow canopy), convenience store (far left), UST field (center), and diesel dispenser islands (red canopy) from the southeast corner of the site, facing northwest.

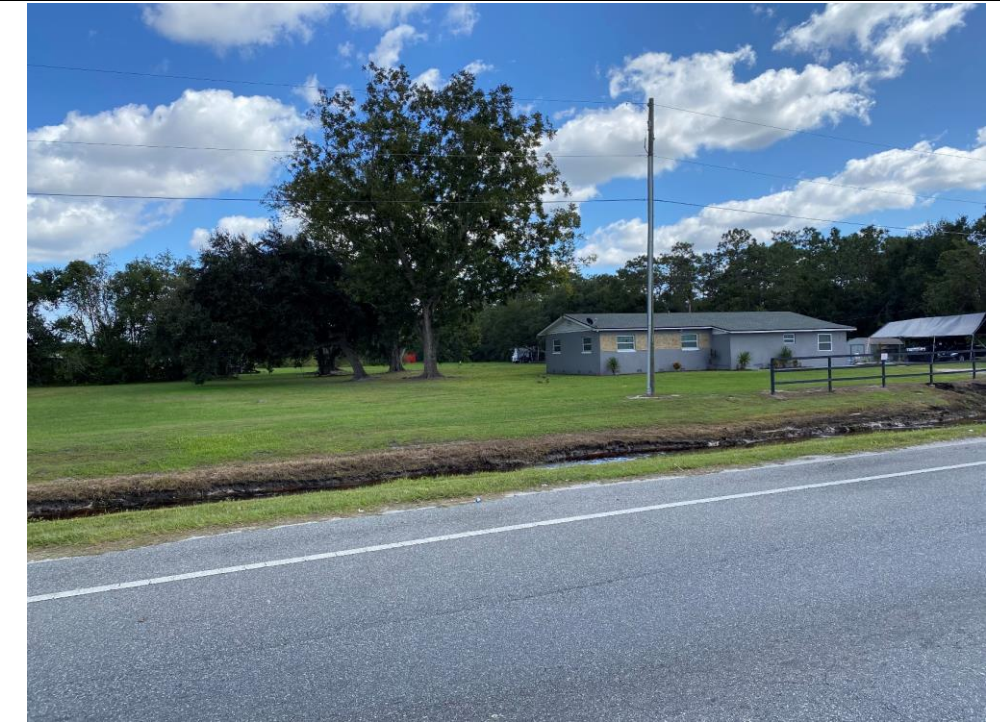
CONCLUSIONS: Based on the apparent unpermitted nature of the former facility, along with the proximity to the Study Area, the former salvage yard facility has been assigned a CRR of **HIGH**.

View of the residence and grassed area behind the residence, from Boggy Creek Road, facing southeast.

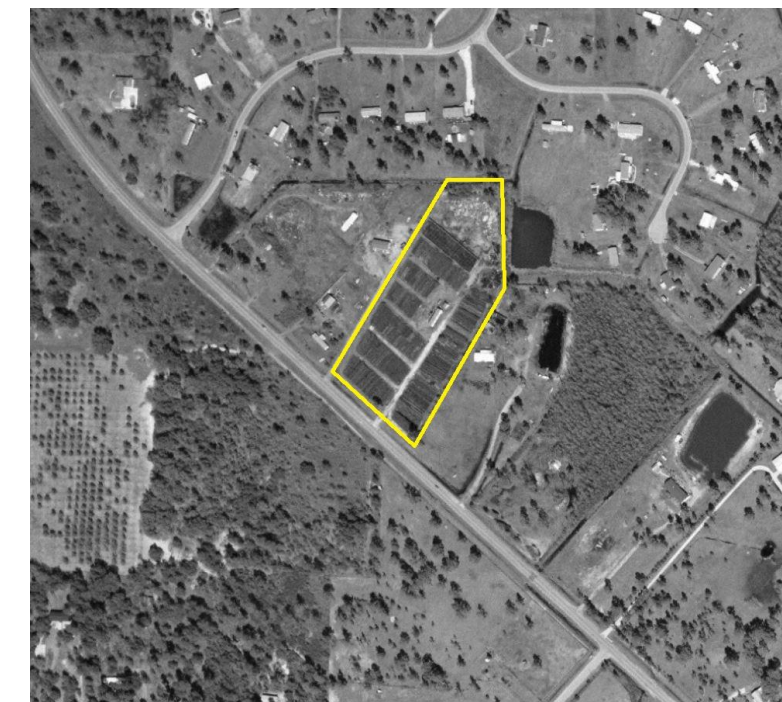
CONCLUSIONS: Due to the potential for agricultural contamination impacts at the site, the nursery facility has been assigned a CRR of **MEDIUM**.

1990 aerial photograph from Google Earth depicting the plant nursery facility.

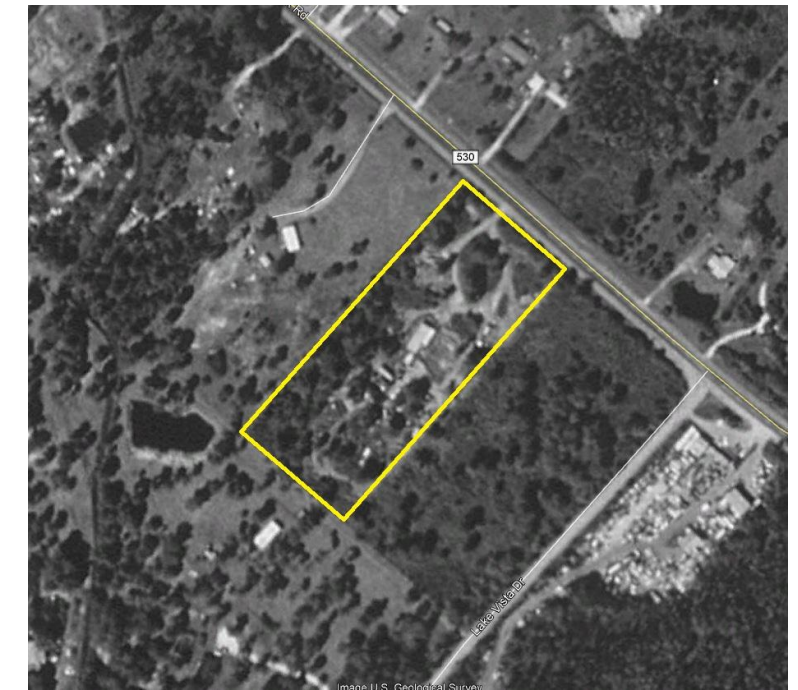
CONCLUSIONS: Due to the potential for agricultural contamination impacts at the site, and the unknown origin of the imported fill material currently located at the site, the former nursery facility has been assigned a CRR of **MEDIUM**.

1994 aerial photograph from Google Earth depicting the former plant nursery facility.

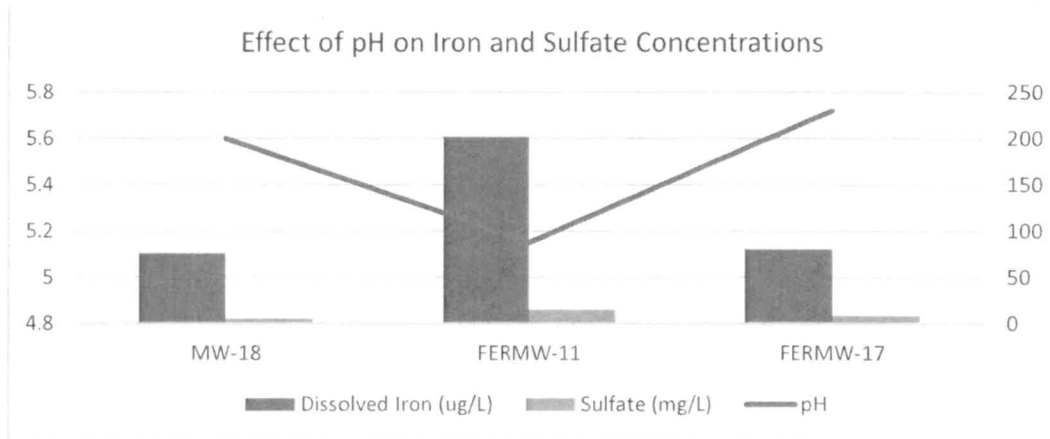
The data indicate that background dissolved iron levels are high, measured at 1590 µg/L in the lateral well MW-5 and 296 µg/L in the up-gradient well MW-1. The dissolved iron concentration drops significantly within the contaminant plume area, ranging from 76 µg/L at the source well MW-18 to 80.4 µg/L in the down-gradient plume well FERMW-17. The variation in the concentration of dissolved iron and sulfate in the system is mainly a function of pH. The solubility of ferrous sulfate (FeSO₄) decreases significantly at a pH greater than 5.5 as iron hydroxides precipitate. As shown below, both the iron and sulfate increase in FERMW-11 when the pH drops below 5.5 (solubilizing ferrous sulfate). This is consistent with the data from other wells which show high levels of iron and sulfate when the pH is below 5.5 (MW-1 and MW-5) and significantly lower levels of these two analytes with the pH is above 5.5 (MW-7).
