CONTAMINATION SCREENING EVALUATION REPORT

BOGGY CREEK ROAD WIDENING From Simpson Road to Narcoossee Road

Osceola County, Florida
PS-20-11479-DG
GEC Project No. 4636E

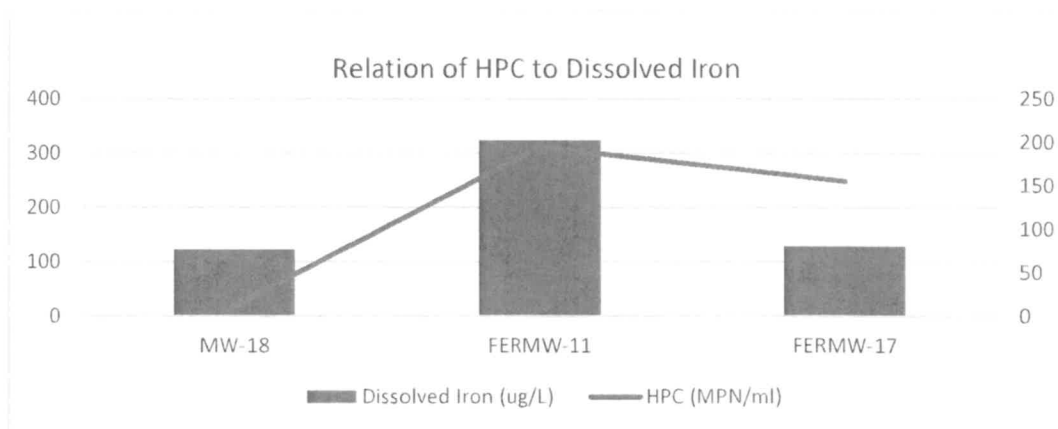
The dissolved oxygen data clearly show that aerobic degradation would be extremely limited without the addition of oxygen to the system through air sparging. However, the data do indicate some limited anaerobic degradation of BTEX compounds may be occurring. Although significantly slower than aerobic degradation, research has shown that anaerobic degradation of aromatic compounds plays a major role for bioremediation processes, and increased knowledge on the anaerobic oxidation of aromatic compounds¹. Besides the reduction of soluble electron acceptors such as nitrate and sulfate, iron(III) reduction is thought to play a major role for the reduction of hydrocarbons at contaminated sites and the biodegradation of BTEX compounds under iron-reducing conditions in situ has been shown in the field². Data from the site shows a correlation between the concentration of heterotrophic bacteria and dissolved iron.
