EXISTING CONDITIONS REPORT

Boggy Creek Road Alignment Study

from Simpson Road to Narcoossee Road Osceola County

Prepared by:
Dewberry Engineers Inc.
800 N. Magnolia Avenue, Suite 1000
Orlando, Florida 32803

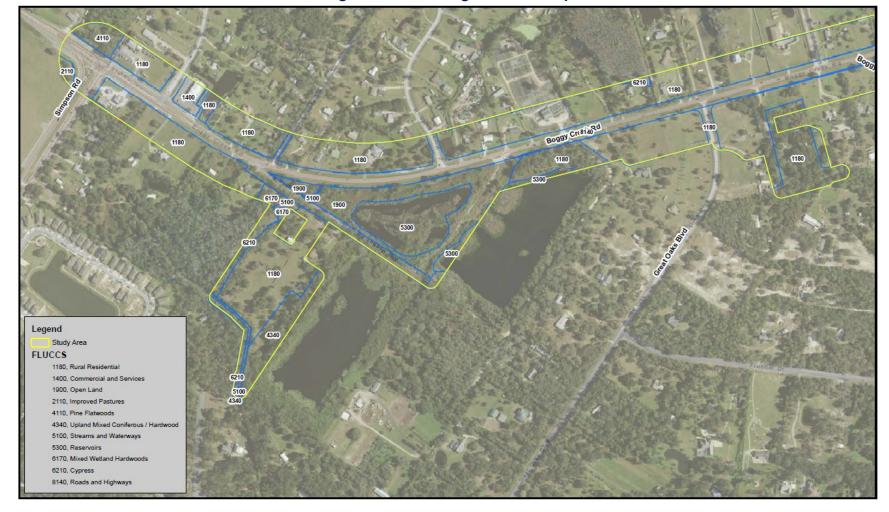
Figure 2-1a: Existing Land Use Map

The existing land use along the project corridor is mainly residential, with a mix of commercial and agricultural lands. Established commercial businesses along the corridor include Circle K, Family Dollar, Wawa, McDonalds and 7-11. Learning institutions include Tohopekaliga High School, East Lake Elementary School and the Renaissance Charter School. The Austin-Tindall Sports Complex is also located along the corridor. Access to the East Lake Fish Camp and The Floridian RV Resort are directly from Boggy Creek Road. A map showing the existing land-use in the vicinity of the study corridor is shown in Figures 2-1a thru 2-1e.
